AGARD CONFERENCE PROCEEDINGS 558

Erosion, Corrosion and Foreign Object Damage Effects in Gas Turbines

Papers presented at the Propulsion and Energetics Panel (PEP) Symposium held in Rotterdam, The Netherlands, 25-28 April 1994.

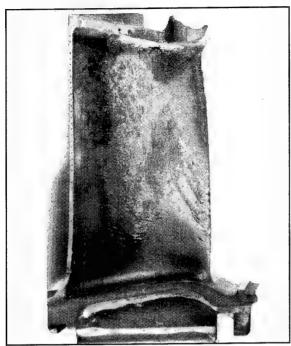
Figure 14

The majority of blades have now been successfully cleaned and returned for service use. (Figures 14 and 15 show typical before and after conditions)

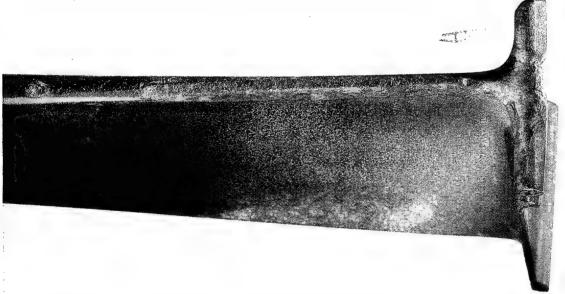
Fig. 4 Service Engine 160 h

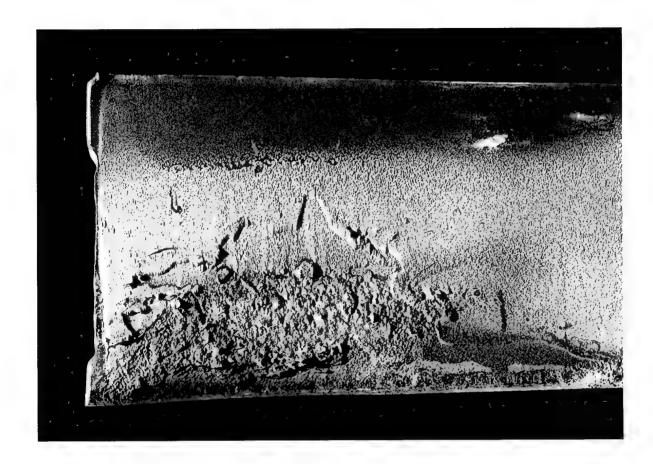
Fig. 9 Typical condition of a blade after testing

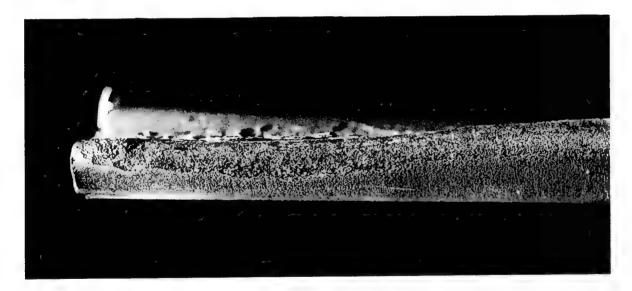
Fig. 10 Leading edge of the blade shown in Fig. 9

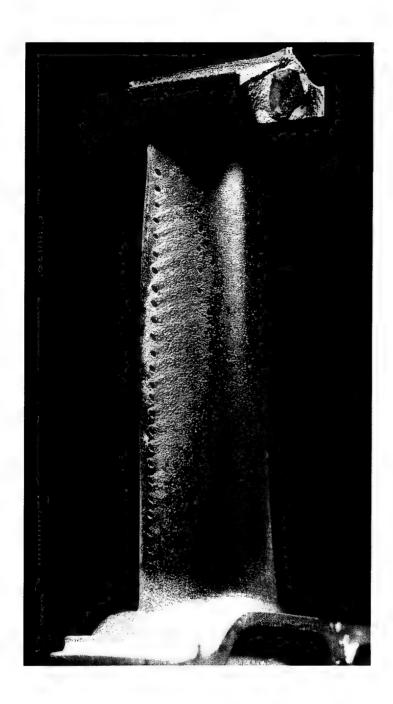
Fig. 11 Typical blade from Case 2

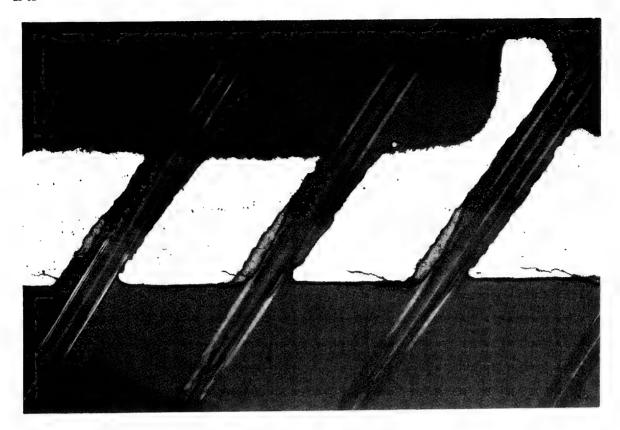
Fig. 12 Longitudinal section through cracked cooling channels showing nickel containing deposit in the channels. Deposit thickness approx. 80 μ m, channel width at this position approx. 260 μ m.

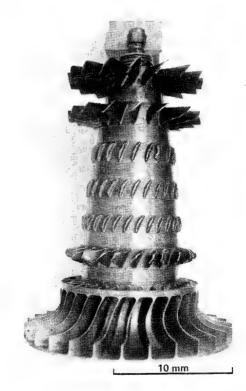
Fig. 3 Compressor rotor of helicopter engine after service failure caused by pitting corrosion (see figure 1c): rotor material 17 - 4 PH steel

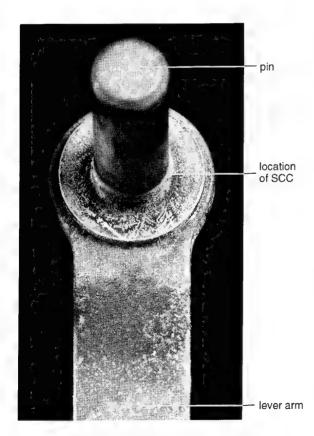
corrosion resistant materials. In the Netherlands an aircraft crash was caused by failure of a pin of a lever of the variable vane system of the engine referred to in Fig. 1d [5]. It turned out that the failure mode was *Stress Corrosion Cracking* (SCC) and that a number of pins in other engines of the same type suffered from SCC. There was a close relationship between the presence of NaCl on these levers (Fig. 6) and the occurrence of SCC (Table 2). Engines operated in the USA showed the same phenomena after about ten times the service hours. This illustrates the *aggressive corrosive conditions in Western Europe*. The solution has been to replace the pin material - Nitronic 60 *steel* - by the *nickel-base* alloy Inconel 625.

Fig. 6 Extreme example of salt deposits on a pin-lever arm assembly for a compressor variable vane: pin material Nitronic 60 steel

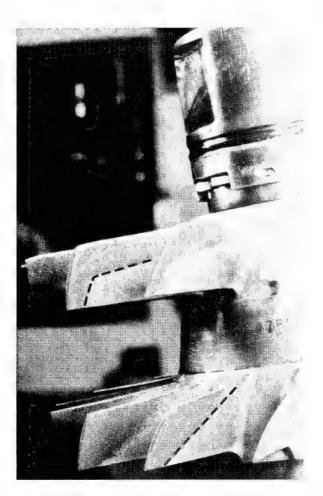
erosion resistant coating. For example, the coating seen in Fig. 9 was applied to combat the corrosion problem addressed in Figs. 1c and 3, but eroded away quickly. It

Fig. 9 The same blades as shown in figures 1c and 3 after 200 h service with an aluminium pigmented coating

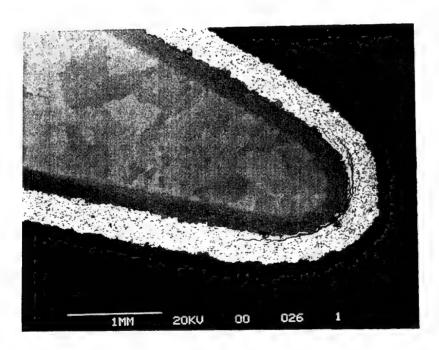
Fig.7 - Cross-section of the tested blade, near the spalled area on the trailing edge.

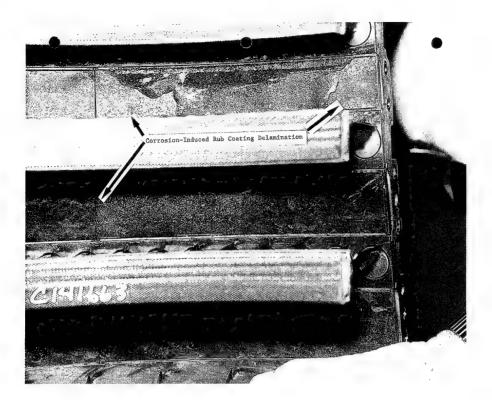
Corrosion-prone hardware identified as a result of the F110

test included the blade-tip rub seals employed in the first three stages of the high-pressure compressor. Corrosion within the bond coating of the seals resulted in widespread delamination of the seals partway through the program (figure 10). The resulting loss of the seal material decreased engine performance by more than five percent and produced impact damage to over one hundred compressor airfoils. As a consequence of this finding, more corrosion resistant materials were employed in the manufacture of the seals and bond coating for production engines.

Figure 10 F110-GE-400 Blade-tip Rub Seals

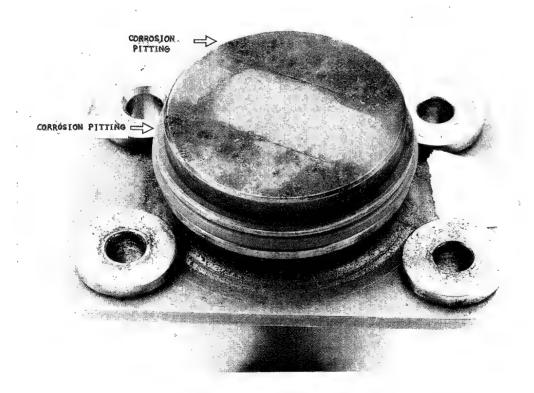
The F404-GE-400 Corrosion Susceptibility Test (1980) also demonstrated its effectiveness in identifying engine hardware with insufficient corrosion resistance for use in the Navy's operational environment (ref 6). Like the F110-GE-400, the test article experienced widespread corrosion-induced delamination of the compressor rub seals which resulted in unacceptable performance losses. Additionally, the engine's fan speed transmitter failed during testing due to corrosion on the sensing surface (figure 11). Several exterior surface areas susceptible to cold corrosion were also identified as a result of the program (e.g., fan inlet guide vanes, fan inlet centerbody).

Figure 11 F404-GE-400 Fan Speed Transmitter
